# Separation issue involving Robinson R44, VH-EYD, and Cessna 152, VH-MRC

Bankstown Airport, New South Wales, 25 August 2016

**ATSB Transport Safety Report**  
Aviation Occurrence Investigation  
AO-2016-107  
Final – 22 November 2016

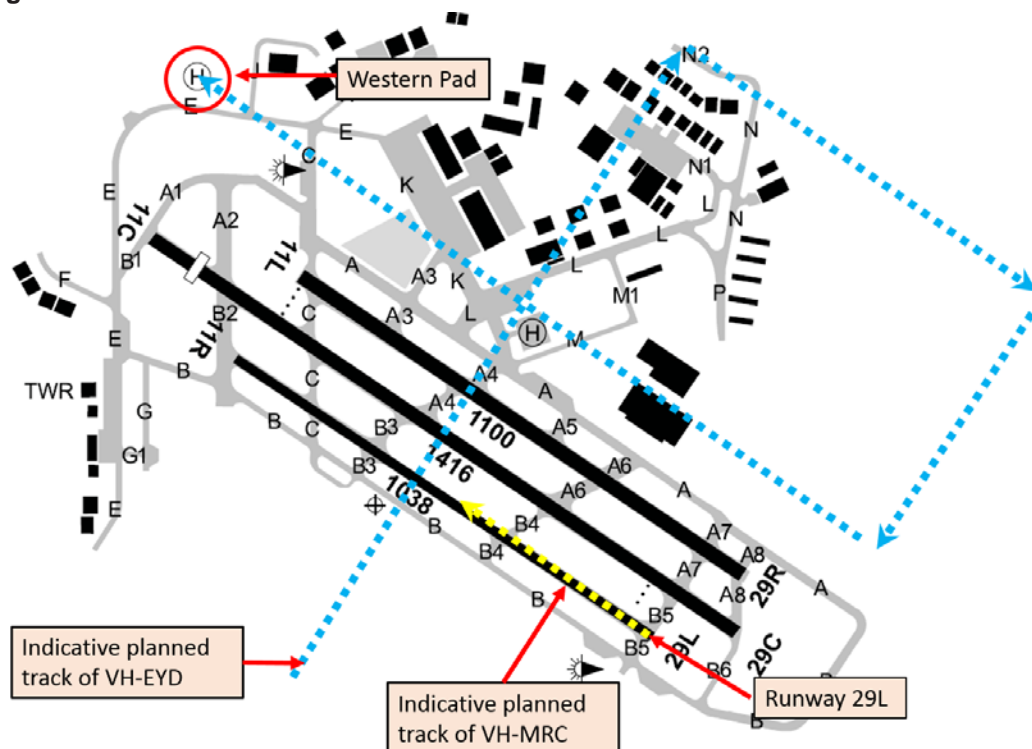
**Figure 2: Indicative aircraft tracks**

The ADC reported that they sighted MRC about mid-way along the runway, lower than the assigned altitude of 1,000 ft, and also sighted EYD about 200 m away at about the same altitude (Figure 2). The ADC immediately issued a safety alert<sup>1</sup> to the pilot of MRC advising of a helicopter (EYD) to their left crossing midfield at 500 ft. The ADC then issued a safety alert to EYD advising of the Cessna (MRC) in the go-around.

The instructor of EYD had already sighted MRC and commenced a right turn to increase separation. On receiving the safety alert, the pilot of EYD continued the right turn to pass behind MRC. EYD landed at the western helipad without further incident. MRC departed to the training area, before returning to land at Bankstown Airport, also without further incident.
